Navigating the Challenges of Intraradicular Threaded Metal Post Removal in Endodontic Retreatment: Clinical Insights and Considerations

The success of nonsurgical endodontic retreatment relies heavily on the removal of intraradicular posts, which are often placed in teeth with extensive crown damage. These posts can obstruct access to the root canal system, complicating thorough cleaning and disinfection. This article presents two clinical cases demonstrating the removal of metal posts and subsequent retreatment.

The primary objective of this article is to present clinical cases that involve the removal of intraradicular posts, followed by subsequent endodontic retreatment. These cases highlight the significance of addressing intraradicular posts and the challenges associated with their removal in the context of endodontic retreatment procedures.

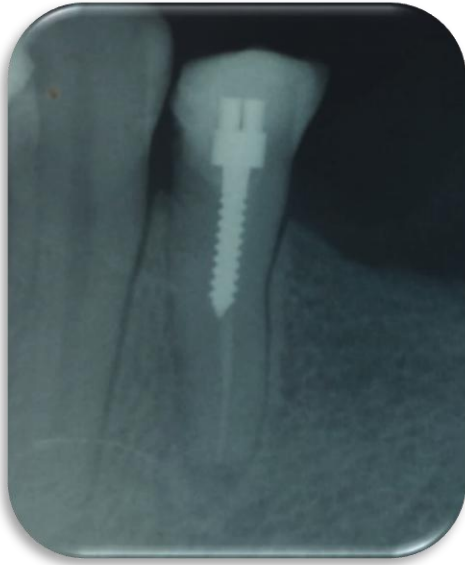
The patient sought dental care, presenting with tooth 34, which had undergone previous endodontic treatment, displayed a periapical image (fig1), and exhibited insufficient endodontic treatment. The tooth was also restored with an exposed metal screw post. To prepare for prosthetic restoration, an endodontic retreatment was initiated.

Figure 1: Preoperative Xray showing a metal post with threads

Initially, a pre-operative periapical X-ray (fig1) revealed the presence of a threaded metal post. The procedure began by removing all restorative materials to expose the head of the post (fig2). During the first attempt using Stiglitz Forceps (fig3), the head of the metal post fractured (fig4).

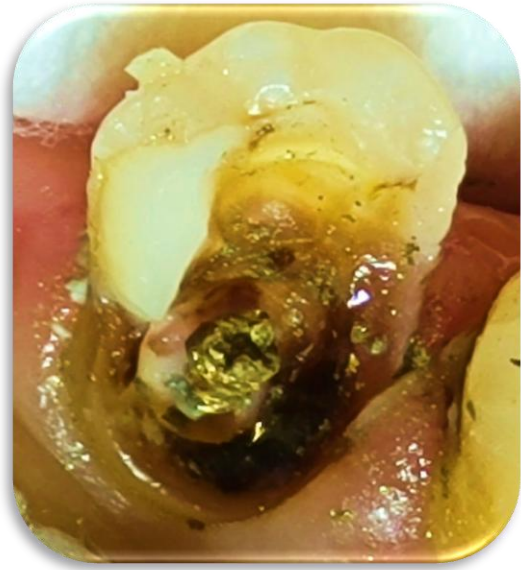
Figure 2: Removing all restorative materials exposing the head of the post

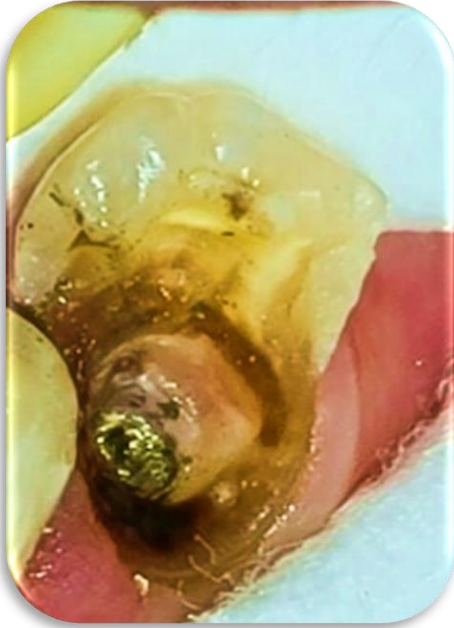
Figure 3: At the first attempt using Stiglitz Forceps, resulting in the fracture of the metal post head

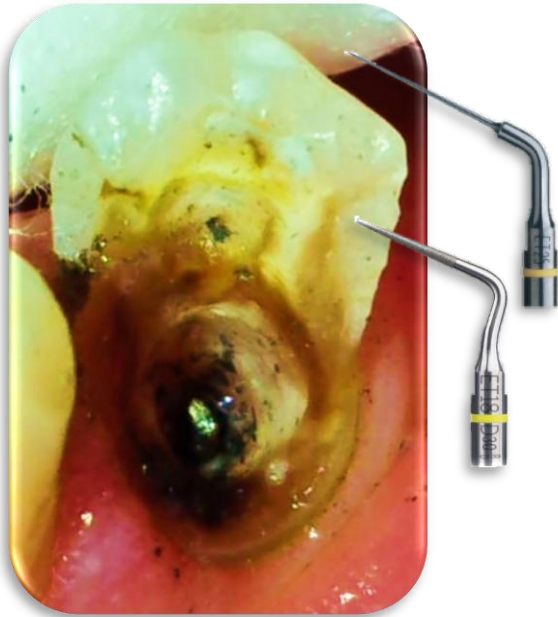
Figure 4: Ultrasonic Tips (ET18D,ET25) were used in counterclock motion around the post associated with continuous irrigation of ClONa

Subsequently, ultrasonic tips (ET18D, ET25) (fig5) were employed in a counterclockwise motion around the post(fig6) while continuously irrigating with Sodium Hypochlorite. Once the post became loosened and mobile with a probe, the fragment was successfully removed using forceps (fig.7).

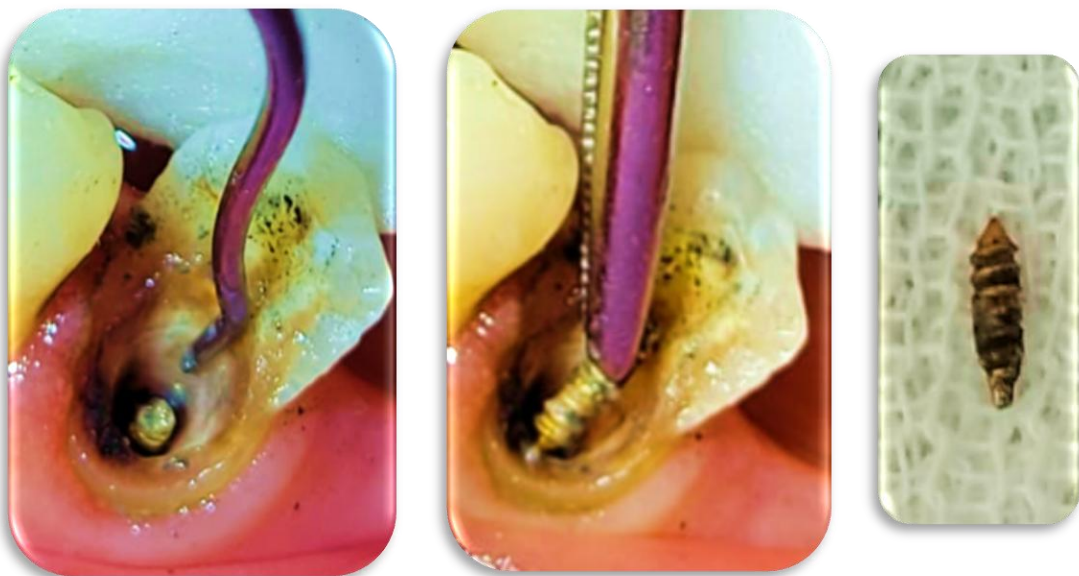
Figure 7: Once the post is loosened and can be moved with a probe, the fragment was removed with a forceps

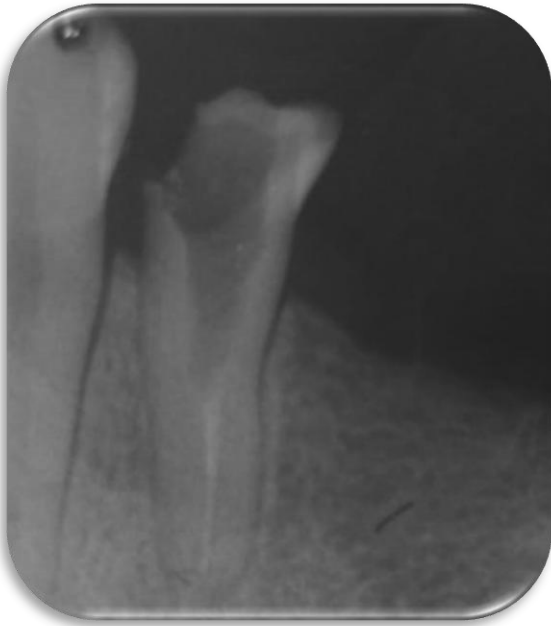
Figure 8: PA xRay
After Post removal

Another X-ray was taken after the post removal (fig.8).

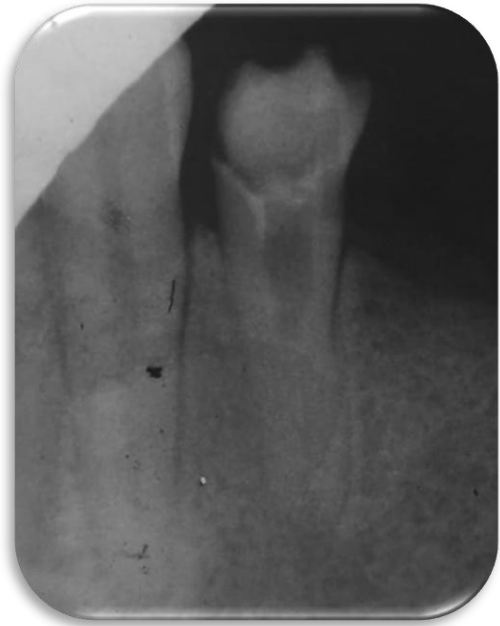
Figure 9: PA xRay
After Gutta percha removal

Pre-endodontic reconstruction was carried out using glass ionomer. Following this, the gutta-percha was removed (fig.9) using RCS retreatment files, and final irrigation was performed with Sodium Hypochlorite, EDTA 17%, and Chlorhexidine 2%. A master cone fit X-ray(fig10) was taken, and the root canal was subsequently obturated using a resin-based sealer, as shown in the post-operative X-ray (fig11).

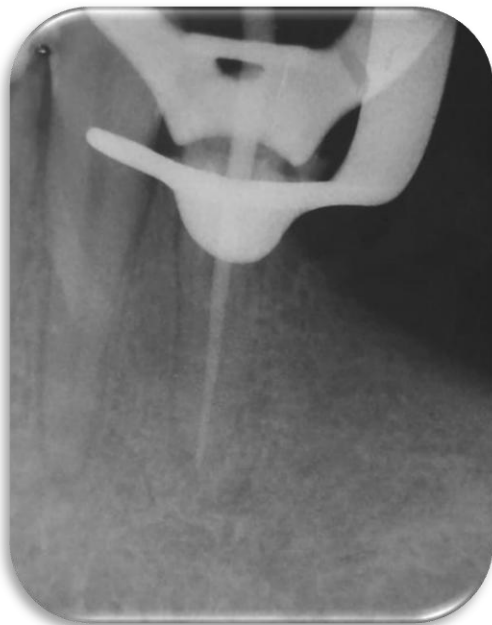
Figure 10: Master
cone fit xRay

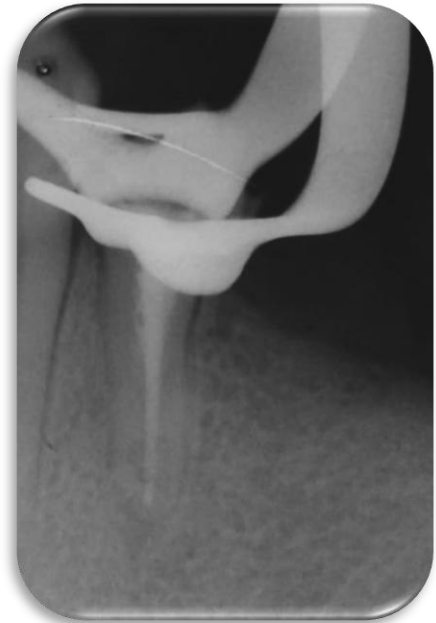
Figure 11: Post
Operative xRay

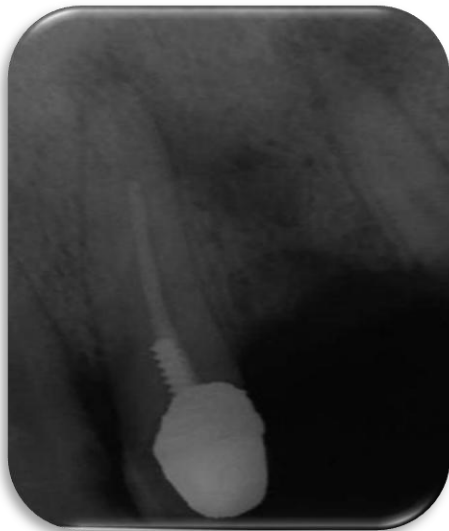
The patient sought dental care, presenting with tooth 13, which had undergone previous endodontic treatment. The tooth displayed a periapical image and exhibited insufficient endodontic treatment. It was restored with a screw post and amalgam(fig12). To prepare for prosthetic restoration, an endodontic retreatment was initiated.

Figure 12: Pre Operative PA xRay showing a metal post with threads

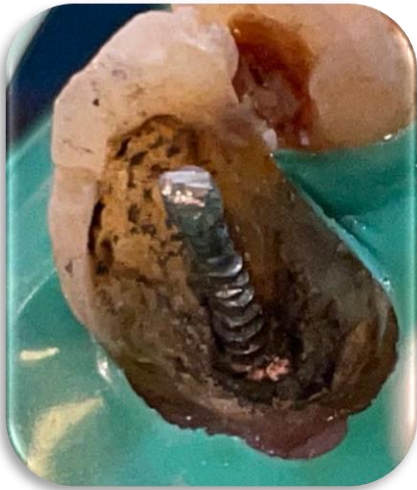
Figure 14: After Removal of the Amalgam and exposing the head of the metal post

A pre-operative periapical X-ray(fig13) revealed the presence of a metal post with threads and an amalgam restoration. The procedure began with the removal of all restorative materials using a trans-metallic burr, exposing the head of the post (fig14).

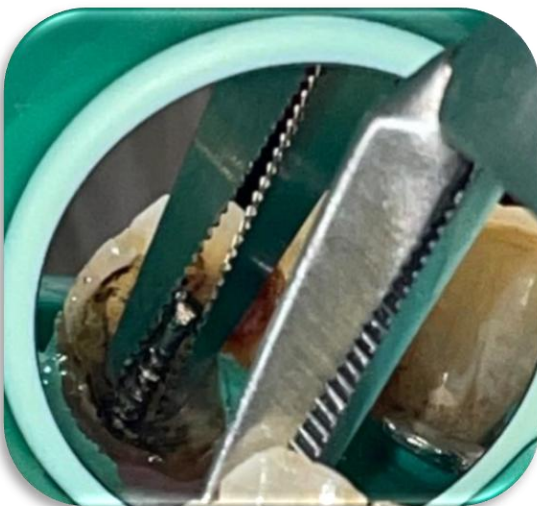
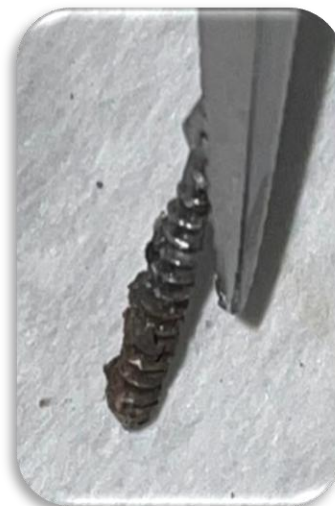
Figure 15: Using a Stiglitz Forceps in a counterclock motion, removing the post in its entirety

A Stiglitz Forceps (fig.15) was employed in a counterclockwise motion to successfully remove the post in its entirety (fig16). Gutta-percha was removed using RCS retreatment files and FKG Endoshaper, followed by a final irrigation was performed with Sodium Hypochlorite, EDTA 17%, and Chlorhexidine 2%.

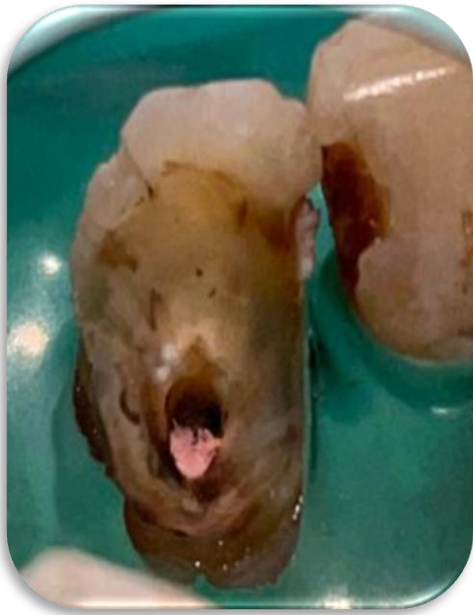
Figure 16: Clinical view after post removal

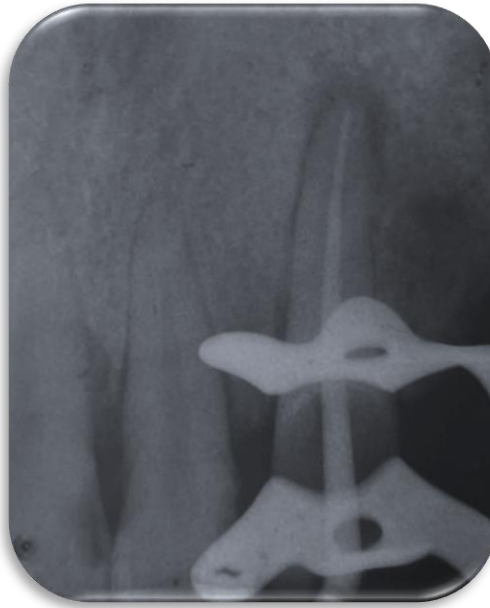
Figure 17: Master cone fit xRay

A master cone fit X-ray (fig.17) was taken, and the root canal was subsequently obturated using a bioceramic-based sealer, as demonstrated in the post-operative X-ray (fig 18).

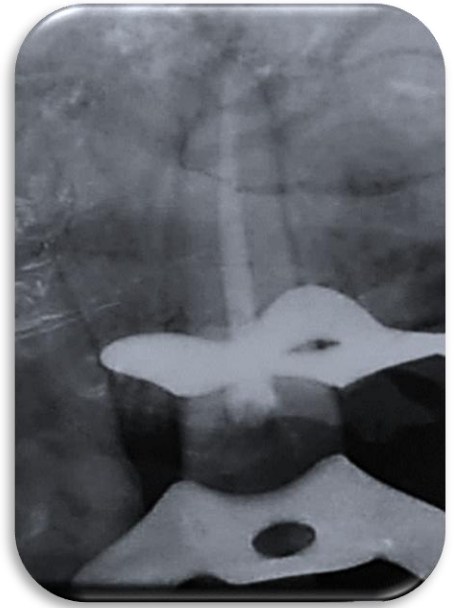
Figure 18: Post Operative xRay
